EFFECT OF THE CURING CONDITION ON THE DURABILITY OF THE INJECTION REFRACTORIES FOR RH DEGASSER REPAIR

Yushi Tsutsui¹, Masaharu Sato¹, Yoshitoshi Saito¹

¹Nippon Steel & Sumitomo Metal Corporation, Oita, Japan

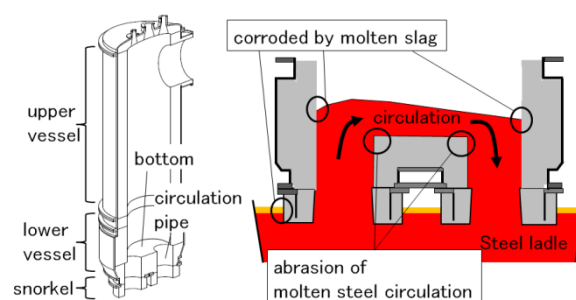
Figure 2. Schematic illustrations of the RH degasser.

Fig. 2 shows schematic illustrations of the RH degasser in Oita Works. The RH equipment consists of an upper vessel, lower vessel, and snorkels. During service, the refractories are severely damaged at the following three specific locations, namely (a) the side wall of the lower vessel, due to corrosion by molten slag, (b) the bottom of the lower vessel due to abrasion by molten steel circulation, and (c) the snorkel periphery is corroded by slag in the molten steel ladle.

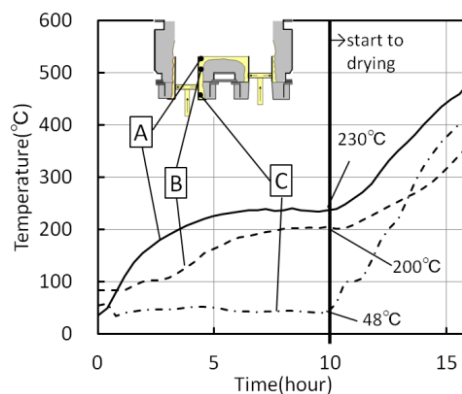
Figure 5. Positions of thermocouples and results of temperature measurement.

In the case of position A, the highest measuring position, the temperature rapidly increased after the injection, and reached 200°C three hours later, and then increased to a constant temperature of 230°C.

In the case of B, the temperature of the injected material reached 100°C two hours after the injection, and became constant at 100°C due to the dehydration of free water; the temperature increased above 100°C after the completion of the dehydration. After that, the temperature continued to increase and reached 200°C after ten hours.

But in the case of C (the lowest measuring position), the temperature of the injected material did not increase, and remained at about 50°C until the start of the drying. Thereafter it rapidly increased to 100°C after the start of drying, and after the completion of dehydration the temperature exceeded 100°C.

It became obvious that the temperatures of positions A and B increased quickly, but not in position C, because of the outside air cooling. Therefore, it was considered that free water remained in position C, and became water vapor during the curing, which affected the refractories above, like in positions A and B, at the temperature higher than 200 °C.

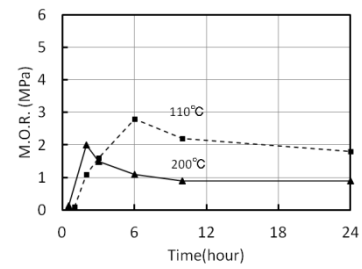
Figure 7. M.O.R. of the specimens cured with a sealing lid.

Fig. 7 shows the relationship between the curing time and the bending strength (M.O.R.) for the lid-covered condition. In the case of curing at 110°C , the curing strength increased to 2.8 MPa after 6 hours of curing and then decreased, reaching 1.8 MPa after 24 hours.

In the case of curing at 200°C , although the strength increased to 1.9 MPa after 2 hours, the strength decreased after that and became 0.9 MPa after 10 hours.

Sugawara et al.^[8] confirmed that cracks occurred in 4~6 hours in the Al₂O₃-MgO castable, under a water vapor pressure of 0.2 MPa, at the boundaries of the coarse grains and matrix, and the strength decreased because the MgO grains in the refractory material hydrated and expanded. This study indicated a decrease of the curing strength of the castable material with a lid in 3~10 hours, as shown in Fig. 7.

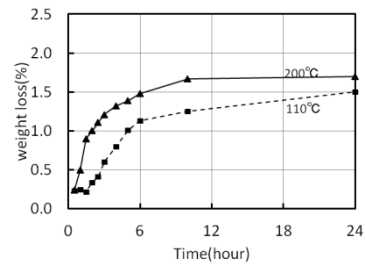
Figure 8. Weight loss of the specimens cured with a sealing lid.

Fig. 8 shows the relationship between the curing time and the weight loss for the condition with a lid. At 110°C , the weight loss proceeded moderately and continued for 24 hours. But at 200°C , the weight loss reached a maximum after 10 hours and then became constant.

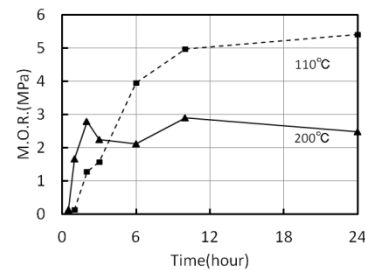
Figure 9. M.O.R. of the specimens cured without a sealing lid.

The relationship between the curing time and the bending strength (M.O.R.), for the condition without a lid, is shown in Fig. 9. In the case of curing at 110°C , the strength increased from 1 hour after curing started and reached about 5 MPa after 10 hours. For the curing at 200°C , the strength increased to 2.9 MPa after 2 hours of curing, and after that the strength trend varied, but reached 2.5 MPa again, after 10 hours.

This report agreed with the test results shown in Figure 9. They didn't mention the reason why the increase of strength stopped after 3 hours. However, it was presumed that the increase of strength stopped because the material was completely dried within the first 4 hours, which was suggested from the sharp decrease in drying rate at the beginning of curing for the condition without a lid, as shown in Fig. 11.

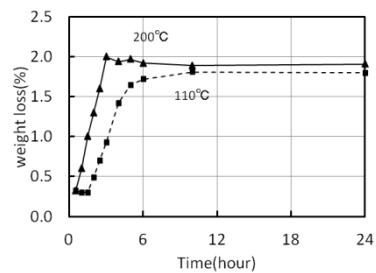
Figure 10. Weight loss of the specimens without a sealing lid.

Fig. 10 shows the relationship between the curing time and the weight loss for the condition without a lid. At 110°C , the weight loss reached a maximum value after 10 hours. But for

the condition at 200°C , the weight loss reached a maximum value after 3 hours, and then reduced and became constant.

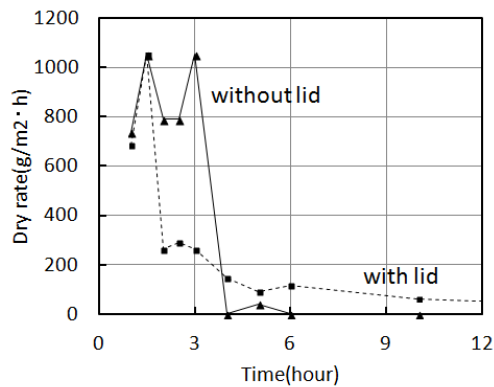
Figure 11. Drying rate of the specimens cured at 200 °C.

For the condition with a lid, the drying rate was high at first but decreased soon, and continued to 12 hours. It could be estimated that the low rate of evaporation didn't remove the large heat of vaporization, and the injected castable material was exposed to high temperature steam for a long time.

From the results mentioned above, it became clear that the curing of the injected material should be completed within four hours and the drying operation should be started after four hours of curing to suppress the hydration of the MgO grains by the high temperature steam, to get high strength material at the bottom of the RH.

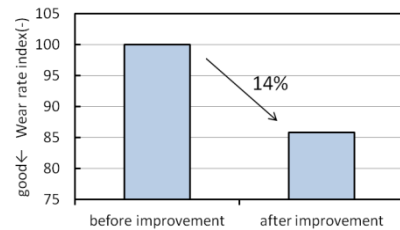
Figure 13. Wear rate index of the injected material.

The wear rate of actual injected material was measured to evaluate the effect of the improved repair method. The wear of new repair material was taken ten times in one campaign of the RH lower vessel, and the average wear rate of the ten measurements is shown in Fig. 13. It was determined that the wear rate of the injected material was reduced (improved) 14%.

A change in curing time was adopted for RH repairs in Oita Works. The curing time was fixed at four hours, as shown in Fig. 12, which shows the repair schedule before and after the improvement. The reduction of the curing time was practiced step by step, with confirmation that there was no explosion during the drying.
