THE DAMAGE MECHANISM OF SiC-MULLITE BRICKS IN CEMENT INDUSTRY

Zhou Yandun, Liu Xijun, Wang Juntao, Chen Songlin, Yuan Lin

Ruitai Materials Technology, Beijing, China

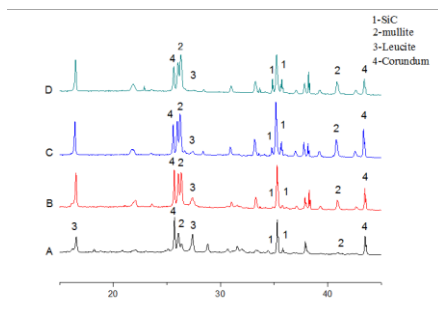
Fig.1: XRD of different layers

XRD patterns illustrate Peak intensity of SiC pattern increased significantly and intensity of SiO_2 decreased, conforming to chemical analysis in diagram3, oxidation of SiC is one factors for damage of SiC-mullite bricks.

As for mullite phase, its intensity in part A is much lower than that in other three parts. It is generally believed that mullite has the characteristic of excellent resistance to chemical erosion and thermal shock, so only mullite in first layer reacted and abraded seriously, that can explainable this reduction.

And there are two new phases, leucite and potassium metaaluminate, existing only in the part A. There is high possibility that Potassium, sodium contained in alkali salt reacted with corundum and mullite phase to form alkali compounds of low melting points like feldspar. Feldspar, with the formulation of KAlSi_3O_8 and bulk density is about 2.54kg/cm^3 . K_2O in cement clinkers may reacted with matrix of SiC-mullite bricks to form feldspar of melting point of

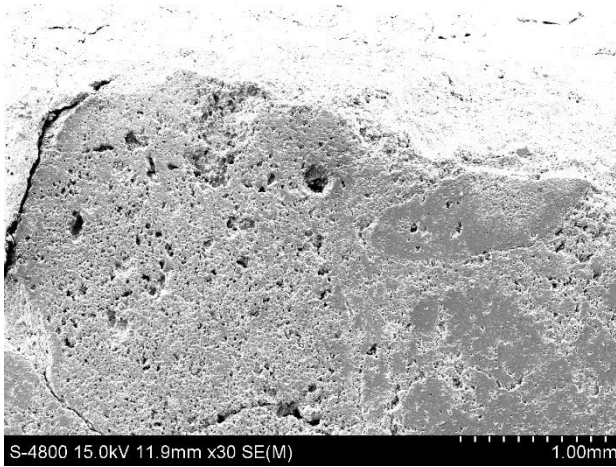
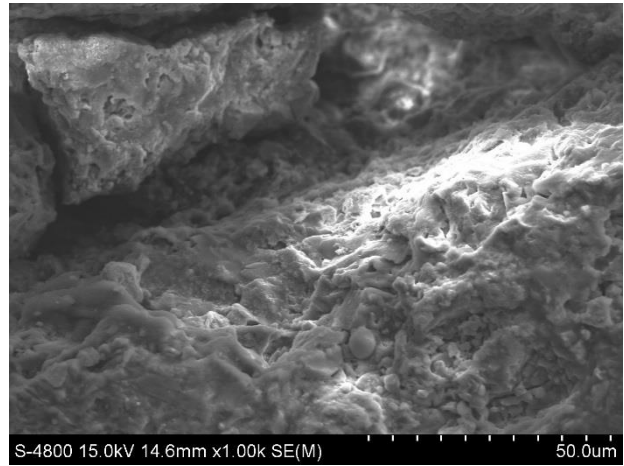
Fig.2: Micrograph of part A with 30x magnification.

Alkali vapor like K_2O , Na_2O , penetrated into bricks through open pores and had in-situ reaction with matrix to form other compounds with low density, like intermediate $K(AlSi_2O_6)$, $KAlO_2$ and so on. However, these new compounds cannot match former position taken by Al_2O_3 , SiO_2 , which leading to structural loose, especially in matrix parts in Fig2. Cement kiln is on the move, so every piece of brick experienced shear strength and stress-strain behavior, loose internal structure are easily destroyed during cement operation [2].

point, which severely influence alkali-resistance and thermal-shock resistance of this brick. So some methods should be taken to avoid this tendency: 1. The additional amount of ZrO_2 can improve refractory materials' resistance to chemical erosion and thermal shock. 2. Open Pores is regarded as channel for alkali invasion and for thermal loss, so works can be done to transform pore size, distribution. Nano-sized pores can efficiently prevent cement clinker erosion and maintain lower thermal conductivity.
