# NEW ANTI-OXIDATION TECHNOLOGY FOR TROUGH AND RUNNERS CASTABLES: A SUCCESSFUL SOLUTION AT ARCELOR MITTAL TUBARÃO BLAST-FURNACE #02

Eric Y. Sako<sup>(1)</sup>, W. Alves<sup>(1)</sup>, B. G. Rangel<sup>(1)</sup>, N. Januario<sup>(1)</sup>, D. F. Galesi<sup>(1)</sup>, F. A. Rodrigues<sup>(1)</sup>, H. Fujiwara<sup>(2)</sup>, T. Komatsu<sup>(2)</sup>, H. Tasaki<sup>(2)</sup>, C. C. Costa<sup>(3)</sup>

<sup>(1)</sup> Saint-Gobain do Brasil – High Performance Refractories - Vinhedo-SP, Brazil

## ABSTRACT

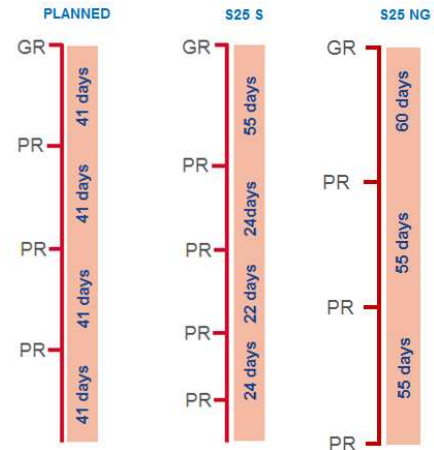
Fig.7. Comparison between planned trough campaign and actual ones with S25 S or S25 NG. GR: General repair; PR: Partial repair.

Due to those positives results, S25 S castable was progressively replaced by S25 NG at AMT BF#02 and long trough campaigns could be attained. In Fig.7, a comparative evolution of the trough campaign is presented, where it is

possible to observe that not only was the instability problem overcome, but also the intervals from repair to repair was extended. This result was of utmost importance to AMT production plan, as it resulted in a higher trough availability rate and consequently reduced the risks to the blast-furnace operation.
