# STUDY ON HOT ALUMINUM RESISTANCE OF Al<sub>2</sub>O<sub>3</sub>-SiO<sub>2</sub> CASTABLES WITH DIFFERENT Al<sub>2</sub>O<sub>3</sub> CONTENTS

The working linings of melting and holding furnaces in aluminum industry are usually damaged by the attack of hot Al and its alloy. In order to improve the service performance of lining, hot aluminum resistance of Al2O3-SiO2 castables with different Al<sub>2</sub>O<sub>3</sub> contents was investigated by the crucible method and the immersion method. The microstructure of the Al<sub>2</sub>O<sub>3</sub>-SiO<sub>2</sub> castables corroded by hot aluminum was also analyzed by means of SEM and EDAX. The results show that: (1) with the increase of the Al<sub>2</sub>O<sub>3</sub> content, the hot aluminum resistance of the castables is enhanced; (2) the castable heat treated at  $1100 \,^{\circ}{\rm C}$ shows worse hot aluminum resistance compared with those heat treated at 110  $\mathbb{C}$ , 800  $\mathbb{C}$  or 1400  $\mathbb{C}$ ; (3) after the hot aluminum penetrates into the interior of castables, Al and even Mg react with SiO<sub>2</sub> in quartz and mullite, reducing SiO<sub>2</sub> into Si, while Al and Mg are oxidized into Al2O3 and

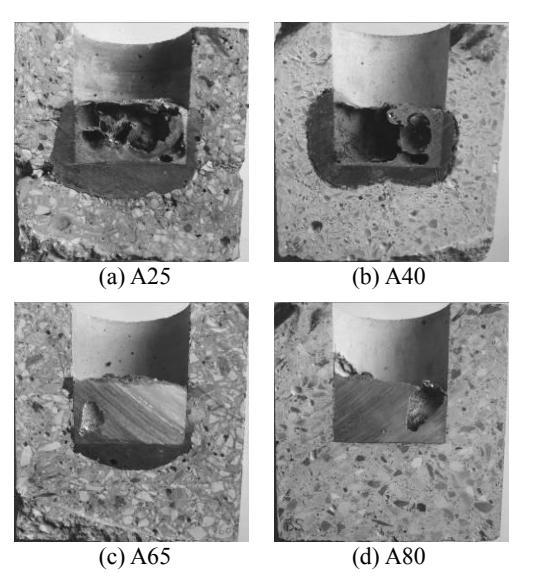
The cross section photos of the specimens with different  $Al_2O_3$  contents after the crucible test are shown in Fig. 2. It is observed that specimens A40 and A25 are seriously corroded and penetrated; specimen A65 shows just a little corrosion and penetration at the bottom while specimen A80 has almost no corrosion and penetration at all. This result shows that the hot aluminum corrosion resistance of the castables is improved with the rising  $Al_2O_3$  content.

Fig. 2: Section photos of specimens with different  $Al_2O_3$  contents after crucible test

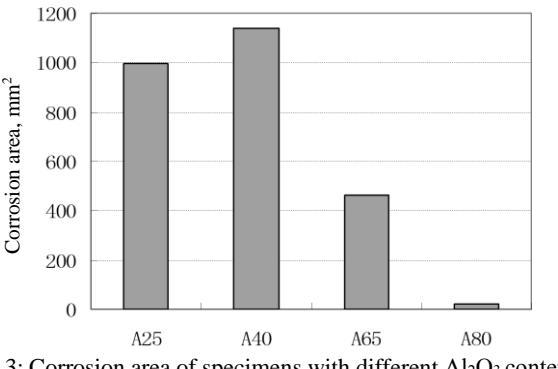
The corrosion area of the specimens with different  $Al_2O_3$  contents after the crucible corrosion test is calculated and given in Fig. 3. As can be seen, specimen A25 has slightly better corrosion resistance to hot aluminum than A40.

Fig. 3: Corrosion area of specimens with different  $Al_2O_3$  content after crucible test

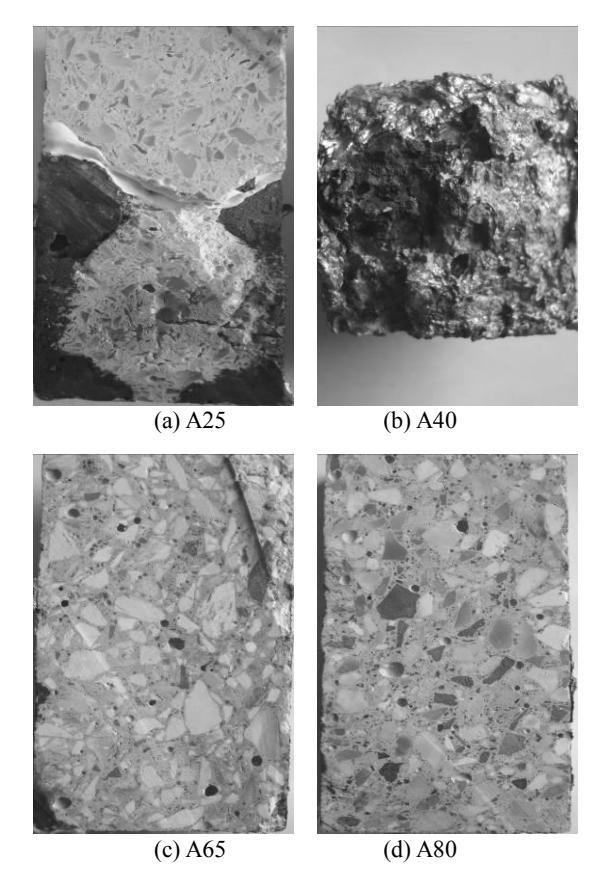
The section photos of specimens with different  $Al_2O_3$  contents after immersion corrosion are shown in Fig. 4. Specimen A40 has collapsed to a mixed lump; A25 is better than A40 but is also seriously corroded. A65 is slightly corroded and A80 is not corroded at all. Therefore, the corrosion resistance results obtained by the two testing methods are consistent.

Fig. 4: Section photos of specimens with different  $Al_2O_3$  contents after immersion corrosion in hot aluminum

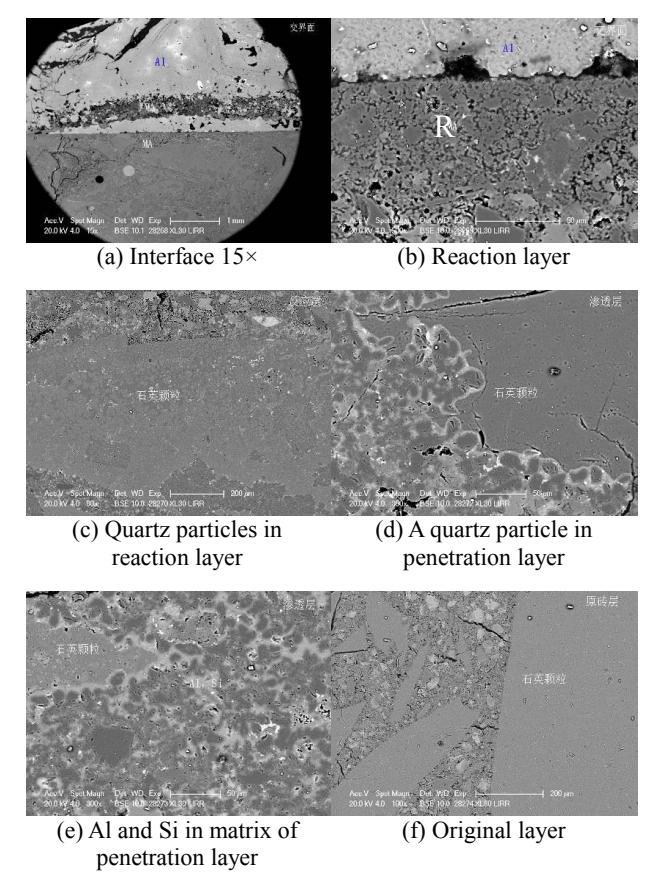
The microstructure of specimen A25 after crucible test is shown in Fig. 5.

As observed from Fig. 5(a), the corroded specimen can be divided into an aluminum residual layer, a reaction layer, a penetration layer, and an original layer. The EDAX results show that the residual aluminum layer is composed of Al 45.35%, Si 42.22%, and Zn 8.65% by mass. Compared with alloy 7075#, Mg disappears, Si content increases greatly, and Zn content remains.

The EDAX result (shown in Fig. 6) of Fig. 5(b) indicates that a spinel rich area exists in the reaction layer. When hot aluminum penetrates into the castable, Mg and Al in the melt react with SiO<sub>2</sub> in the castable forming MgO and Al<sub>2</sub>O<sub>3</sub>, while SiO<sub>2</sub> is reduced into Si. Subsequently, MgO reacts with Al<sub>2</sub>O<sub>3</sub> in the castable or the formed Al<sub>2</sub>O<sub>3</sub>, forming spinel.

Fig. 5(c) shows the corrosion state of the quartz particles in the reaction layer. Although the quartz particles show their shapes remained,  $SiO_2$  has reacted with Al forming  $Al_2O_3$  and is replaced by the formed  $Al_2O_3$ .

In Fig. 5(d), the quartz particles in the penetration layer are being partly corroded by the hot aluminum and the margins of the particles are not clear.

In Fig. 5(e), Al and Si phases link together in the penetration matrix

Fig. 5(f) is the microstructure of the original layer. The quartz particles show clear and the original shapes.

Fig. 5: SEM photographs of specimen A25 after crucible corrosion test

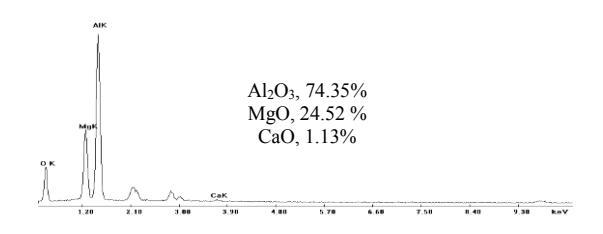
Fig. 6: EDAX of microzone R in Fig. 5(b)

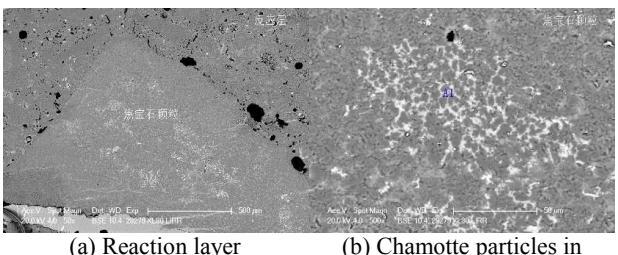
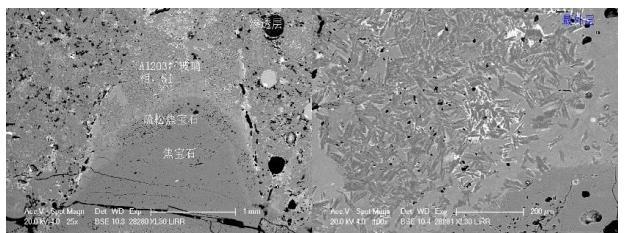
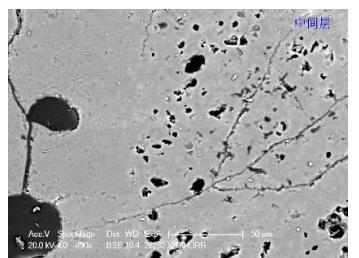
The microstructure of specimen A40 after crucible corrosion test is shown in Fig. 7. Similar with A25, a spinel rich area exists in the boundary between the reaction layer and the aluminum residual layer. There are large amounts of Al and formed Si in the reaction layer.

As shown in Fig. 7(a), the chamotte particles are relatively complete in the reaction layer.

The chamotte particles in the reaction layer were enlarged in Fig. 7(b). Quartz and mullite get penetrated by hot aluminum: SiO<sub>2</sub> in quartz and mullite reacts with Al, forming Si and Al<sub>2</sub>O<sub>3</sub>.

As observed in Fig. 7(c), three layers form after the chamotte particles are corroded: the outer layer is composed of the formed Al<sub>2</sub>O<sub>3</sub>, glass phase and metal Si (Fig. 7(d)); the middle layer is basically chamotte with loose structure (Fig. 7(e)); the inner layer is the original chamotte.

reaction layer

(c) Chamotte particles in penetration layer

(d) Outer layer of chamotte particles in penetration layer

(e) Middle layer of chamotte particles in penetration layer

Fig. 7: SEM photographs of specimen A40 after crucible corrosion test

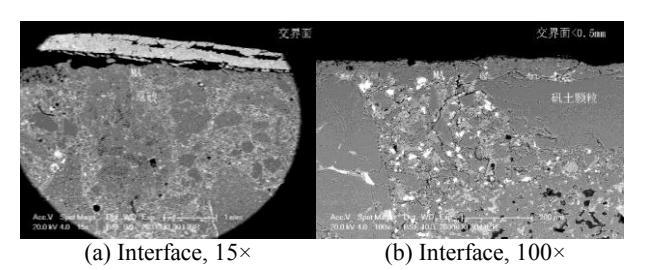
The microstructure images of specimen A80 after crucible corrosion test are shown in Fig. 8. Since it has low SiO<sub>2</sub> content, the corrosion is slight: a spinel rich area is observed 0.5 mm away from the surface. However, the spinel rich area is dense so it can impede the penetration of hot aluminum into the interior of the castable.

Fig. 8: SEM photographs of specimen A80 after crucible corrosion test

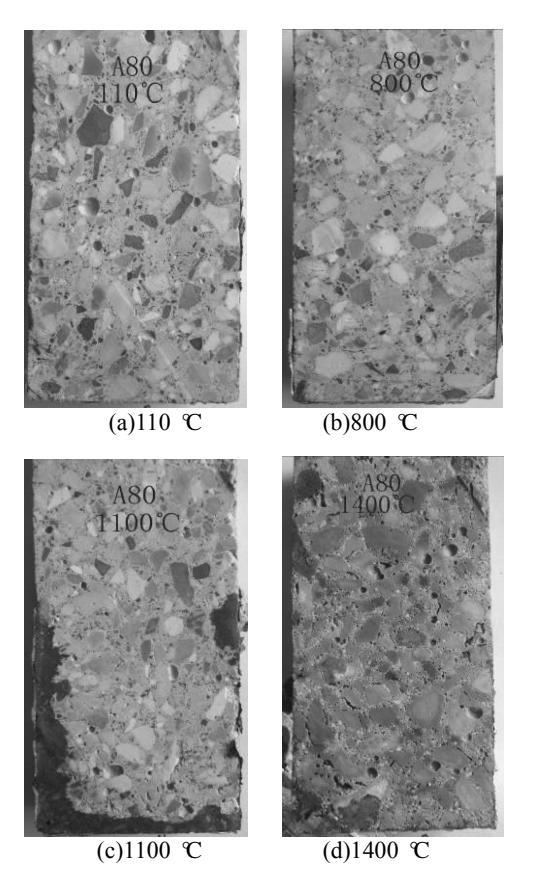
Cross section photos of specimens A80 treated at different temperatures are shown in Fig. 9. The test specimens treated at 110 °C and 800 °C respectively have no obvious difference for the hot Al corrosion. The specimen treated at 1100 °C has loose structure as the hydration products of cement decompose and the it is not sintered, resulting in a poor corrosion resistance to hot Al. The specimen treated at 1400  $^{\circ}$ C shows better corrosion resistance because it relatively dense by sintering.

Fig. 9: Section photos of specimen A80 treated at different temperatures after corrosion by immersion in hot aluminum

(2) The Al<sub>2</sub>O<sub>3</sub>-SiO<sub>2</sub> based castables with 80% Al<sub>2</sub>O<sub>3</sub> content heat treated at temperatures below 800 °C have no obviously difference of corrosion resistance to hot aluminum. While castable specimen treated at 1100 °C indicates poor corrosion resistance. However, when the treatment temperature rises to 1400 °C, the castable specimen is relatively dense by sintering, obtaining better corrosion resistance than that at 1100 °C.
